Report on the corrosion of the low voltage warm cables and feedthrough pins during the summer 2005 cold test of endcap A

Paul Poffenberger
University of Victoria, B.C., Canada

November 22, 2006

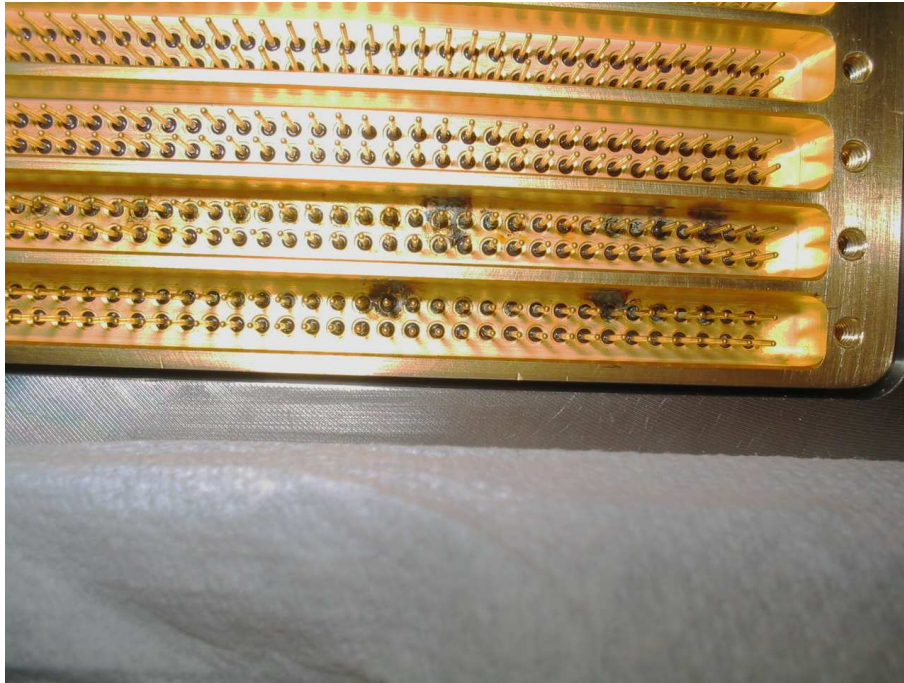
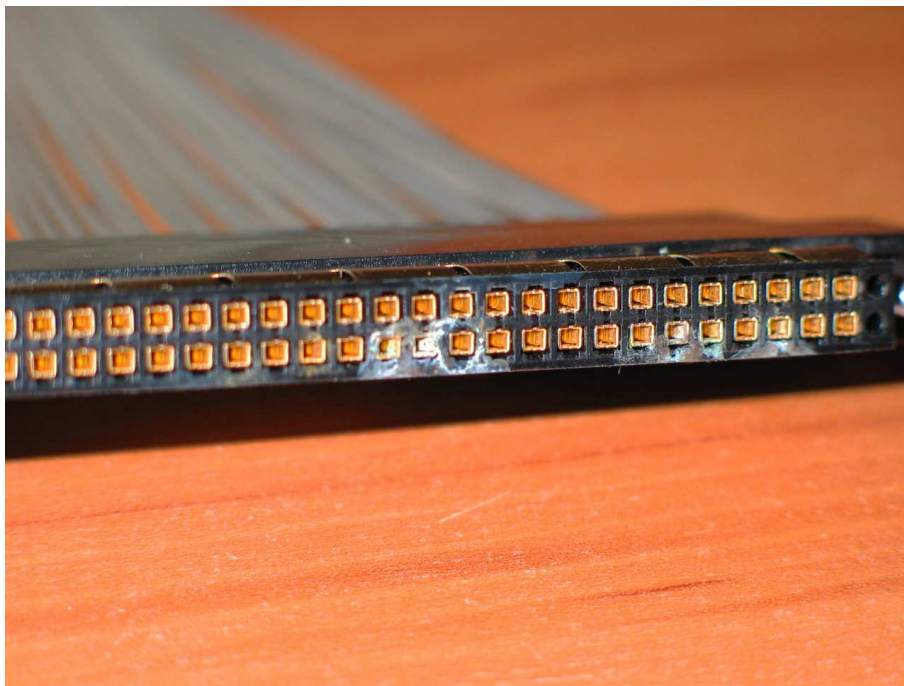
The cold test of endcap A performed in Bat 180 during the summer of 2005 was done during a period when the weather conditions were particularly hot and humid. Although the feedthroughs are equipped with heaters to prevent condensation, the heaters were held at a temperature of 20 °C during the cold test. This temperature was below the dew point and consequently resulted in corrosion on some of the feedthrough pins of the low voltage channels as well as on the corresponding sockets of the low voltage warm cables. The corrosion was discovered when uninstalling the pedestals of the lower quadrants of endcap A in preparation for lowering into the ATLAS pit. Pictures of one corroded pin carrier and low voltage warm cable of endcap A

are shown in Figure 1. The low voltage feedthrough pins and warm cables of the lower quadrants of endcap C were subsequently inspected but showed no sign of corrosion; the cold test of that endcap was done during winter months early in 2005 when the dew point was well below the feedthrough heater temperature of 20 °C.

A small sample of the corrosion on a warm cable was removed and analyzed at CERN using an electron microscope technique. The elements found in the sample were primarily copper and oxygen, along with a trace amount of carbon which could have come from some contamination of the sample. The presence of copper and oxygen suggest that the corrosion was simply copper oxide, as would be expected. The relative amounts found for those two elements were not consistent with the copper oxide hypothesis, so the exact nature of the corrosion remains uncertain. The important thing to note, however, is the absence of any elements which might have come from solder flux or any other undesirable exotic chemical residue in the warm cables.

Figure 1: Corroded pin carrier (top) and low voltage warm cable (bottom) from endcap A.

All low voltage warm cables on endcap A were uninstalled and returned to the University of Victoria in February 2006 for testing and repair. The testing consisted of plugging both ends of a cable into a test apparatus which performed a precise resistance measurement between the two ends of each channel. The precision is high enough to provide a good measure of the contact resistance between the pins of the test apparatus and the corroded

Repair of the low voltage warm cables consisted of placing them in an ultrasonic bath of methyl alcohol for about 30 minutes each. The resistance tests were then repeated after the ultrasonic bath, and the results of those tests are summarized in Figures 4 and 5. After cleaning, the resistance of all channels are very uniform and close to $40 \text{ m}\Omega$, indicating consistent good electrical contact between the pins and sockets after the ultrasonic bath.

During June 2006, this cleaning prescription was applied to all corroded pincarriers on the HEC feedthroughs of Endcap A.

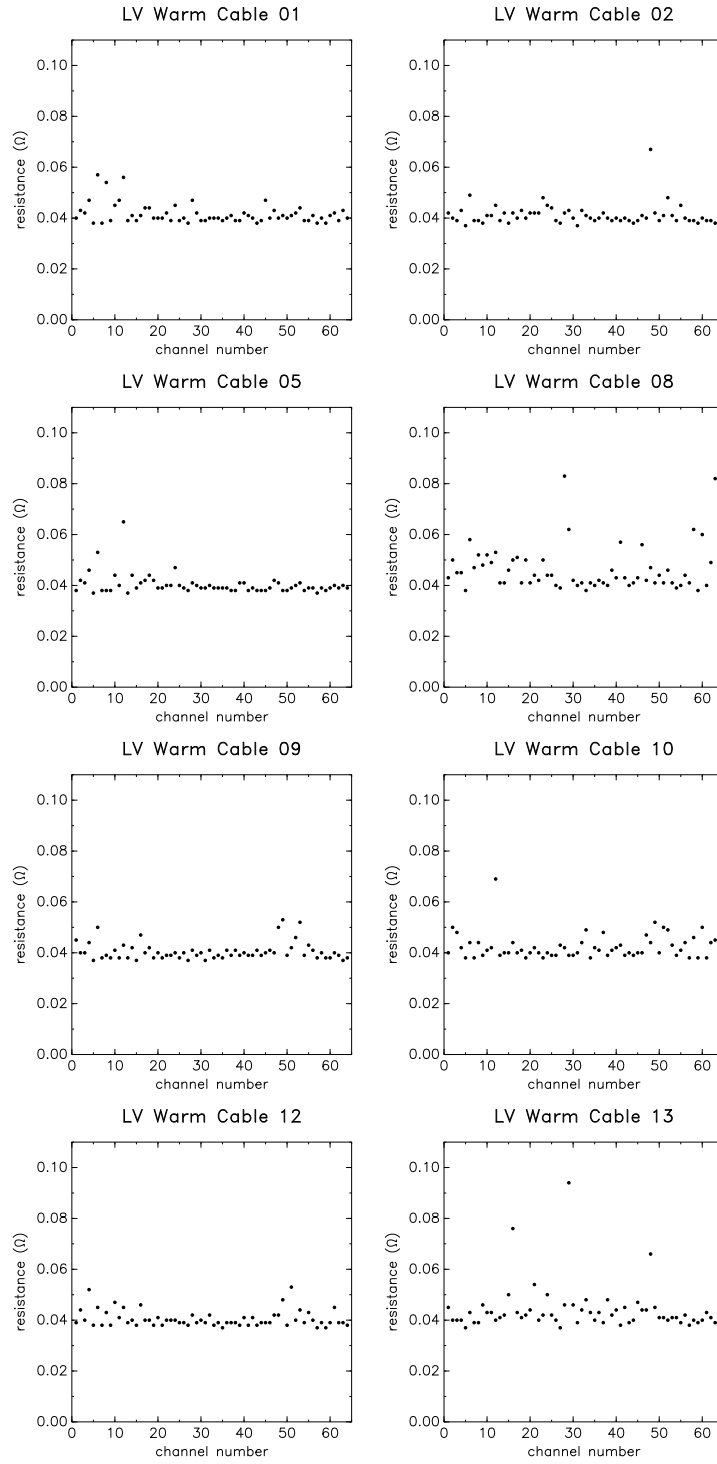
sockets of the cable. This test was done before any repair of the cable, and the results are summarized in Figures 2 and 3. As is evident in the resistance plots, there are many channels whose resistance lies significantly above the $\sim 40 \text{ m}\Omega$ average.

Figure 2: Resistances measured before ultrasonic bath (a)

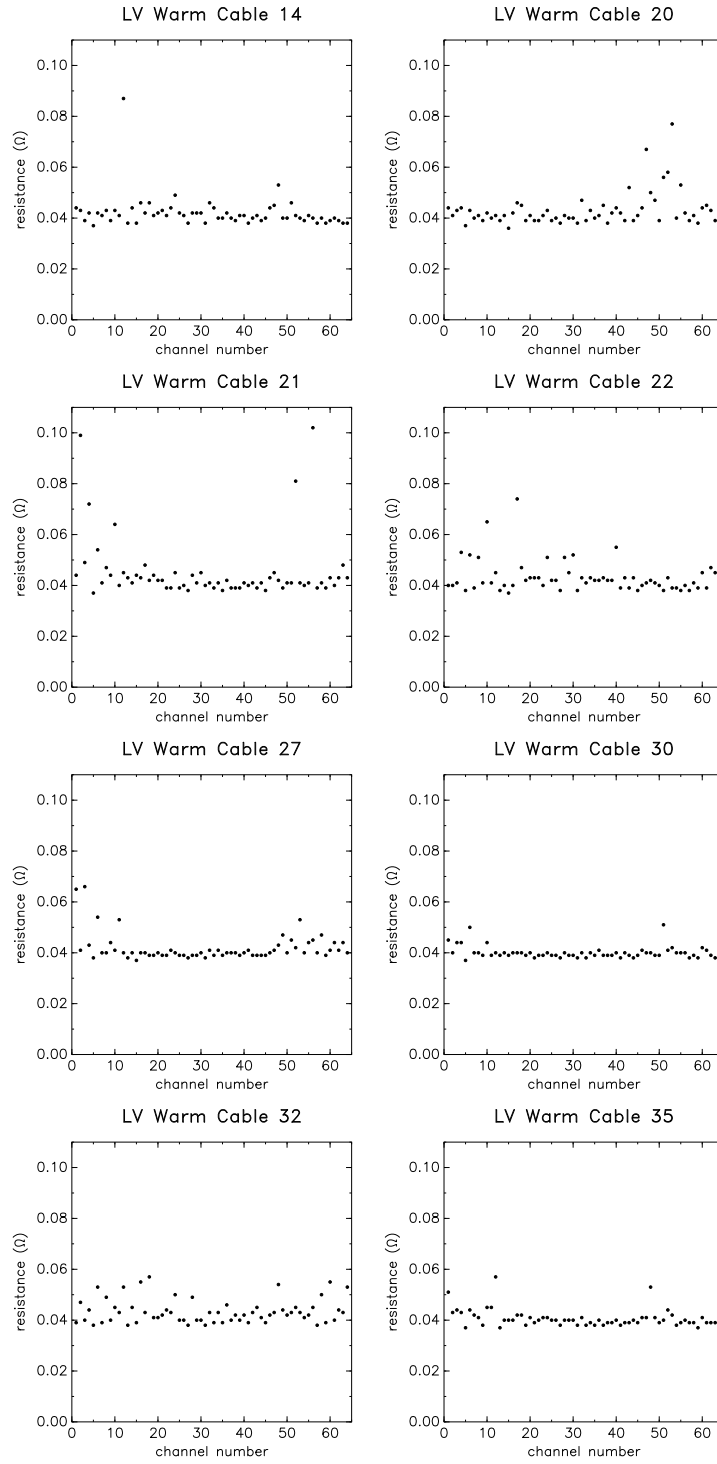
Figure 3: Resistances measured before ultrasonic bath (b)

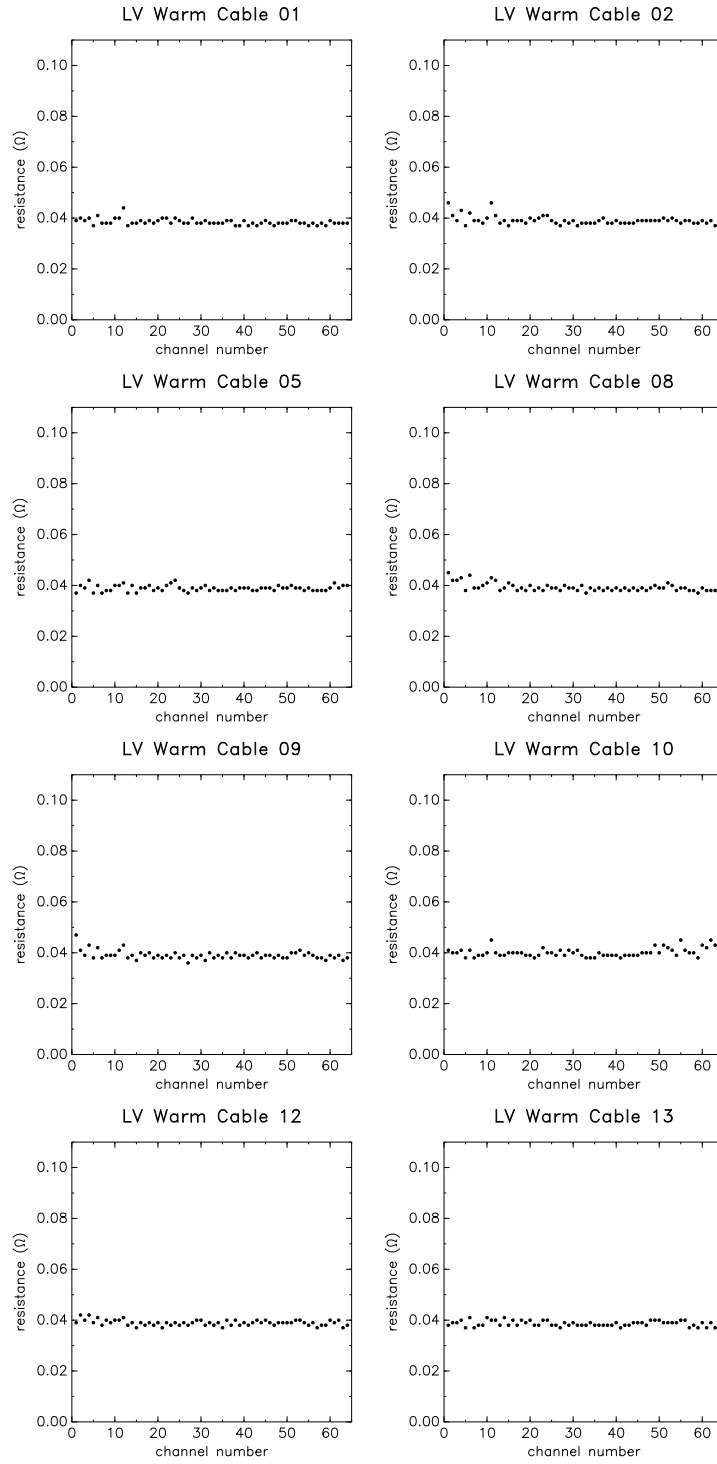
Figure 4: Resistances measured after ultrasonic bath (a)

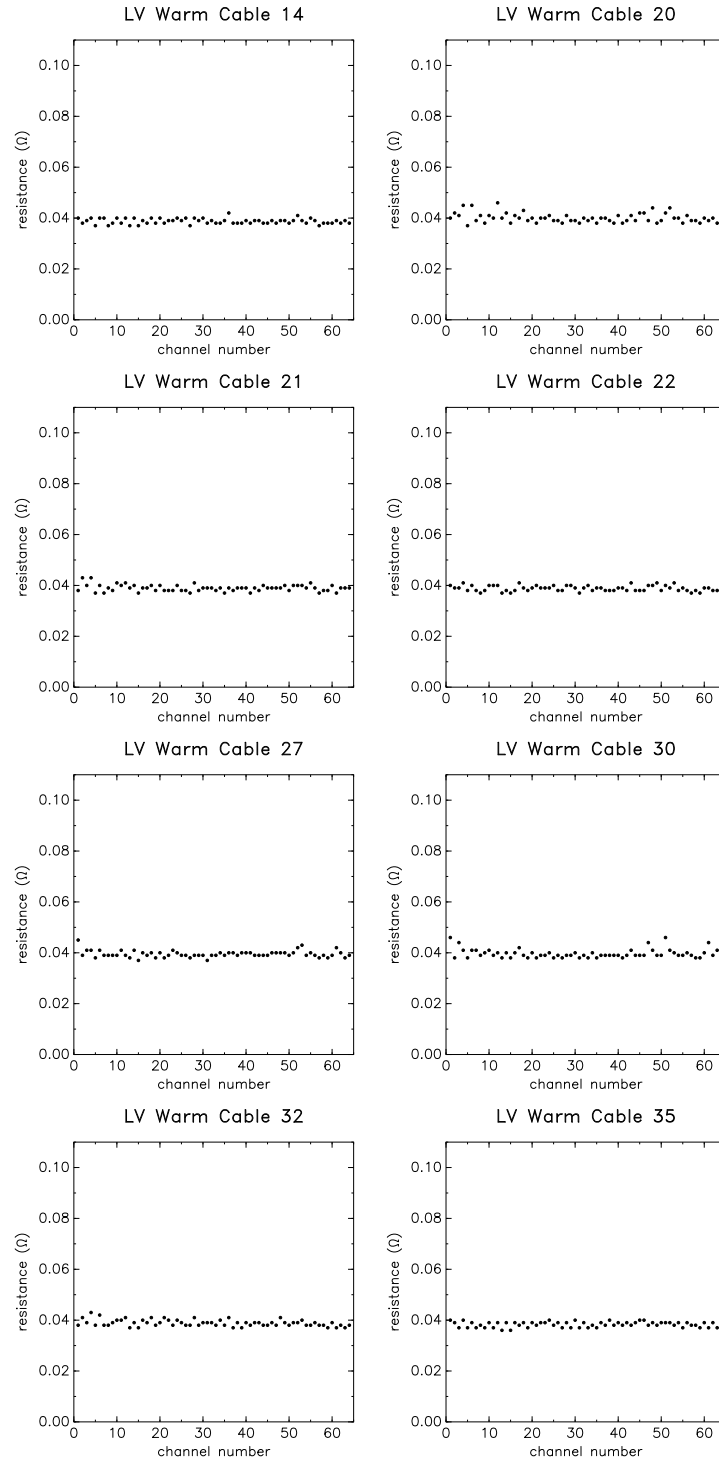
Figure 5: Resistances measured after ultrasonic bath (b)

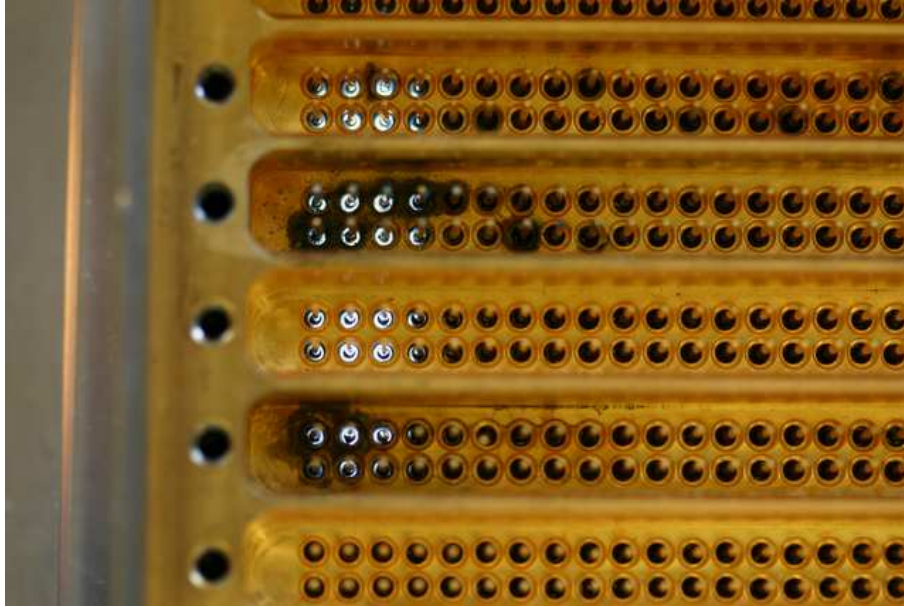
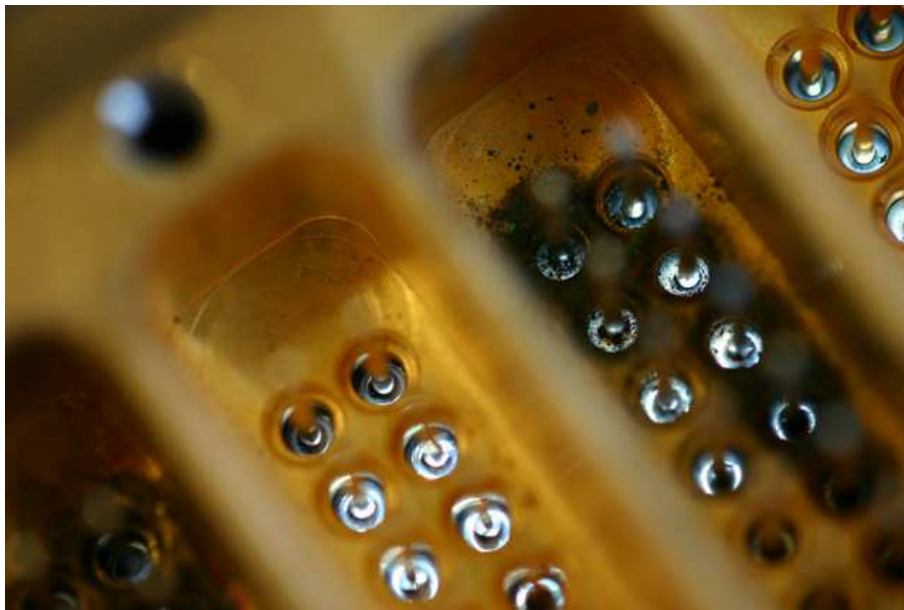
The pincarriers deliberately corroded in the Victoria lab provided good samples for testing the effectiveness of various cleaning techniques. The insulator between the pins and the pincarrier body is glass, so the corroded pincarriers could be placed on a light table and the back-lit glass beads viewed with a microscope. Any corrosion residue which ends up on the glass bead could potentially lead to a conduction path between the pin and the pincarrier body. A picture of one such corroded pincarrier with corrosion residue on the insulating glass beads is shown in Figure 6. Resistance between a pin and the pincarrier body was also measured using an ohmmeter cable of measuring in the $\text{T}\Omega$ range. Some resistances before cleaning were measured as low as $25 \text{ M}\Omega$.

Figure 6: Corroded pin carrier from Victoria bench tests. The pincarrier is on a light table to illuminate the glass bead insulating the pin from the pincarrier body. Note the corrosion debris on some of the glass beads in the bottom picture.

A number of cleaning methods were tried, using both visual inspection and measured resistance to check their effectiveness. The most effective cleaning method found was to dip a thin Teflon capillary tube into alcohol, then place the tube over a pincarrier pin and onto the contaminated glass bead. The dimensions of the Teflon tube were carefully chosen so that the ID of the tube fit easily over the pin, and the wall thickness of the tube covered most of the glass bead. With the glass bead wetted by the alcohol in the tube, the tube was gently twirled in order to *scrub* the glass bead. The loosened residue was finally blown away using canned air. After cleaning, resistance between pin and pincarrier body was typically on the order of $1 \text{ T}\Omega$ and the glass beads visually much cleaner.

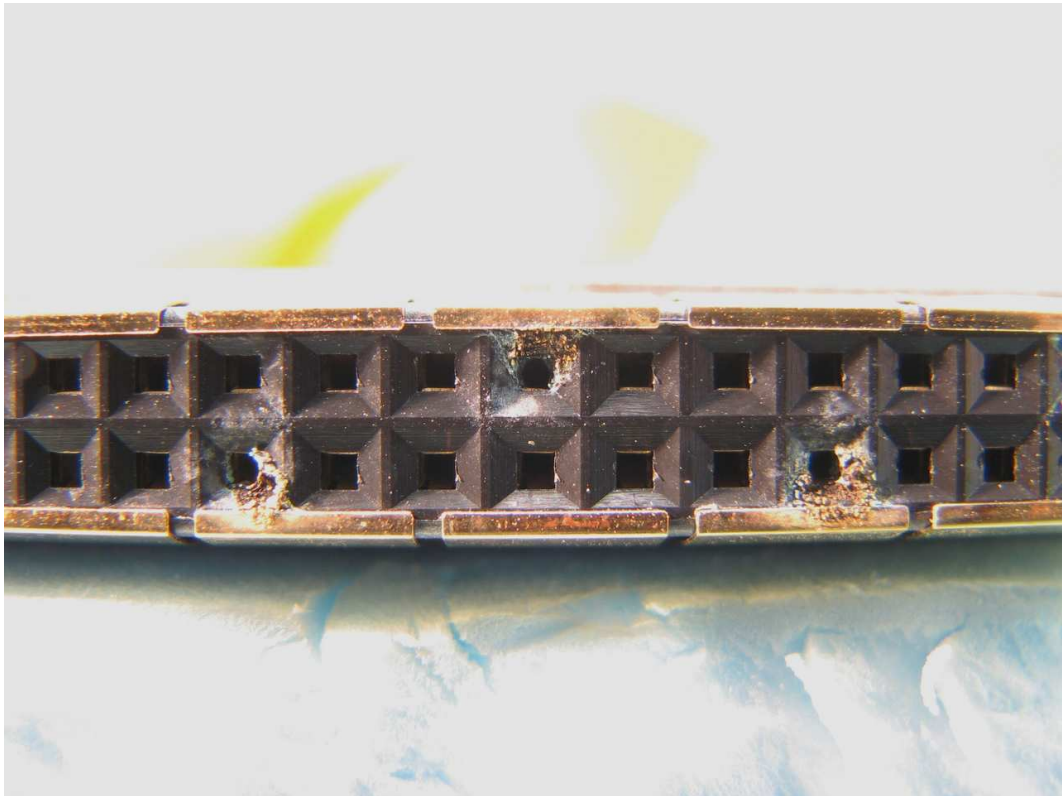
The corrosion was easily reproduced on a test bench in Victoria using parts left over from the construction of the feedthroughs. A cable was attached to a pincarrier wetted with distilled water. A power supply was then used to apply 24 V to some of the lines of the cable, with the pincarrier body attached to ground. The apparatus was typically left in this state for twelve hours, after which the cable was removed and the pincarrier and cable connector inspected. As can be seen in Figures 6 and 7, there is significant corrosion on those channels which were held at 24 V. The pincarriers thus corroded provided test samples for gauging the effectiveness of various cleaning methods, discussed below in Section 2.2.

Figure 7: Corroded cable from Victoria bench tests.
